Archaeological Documentation During a Securing and Restoration Project: An Example of a Successful Approach

The Case of the Castle of Larciano (Pistoia – Italy)

Abstract: This paper presents the photogrammetric survey of a medieval castle and the challenges we faced in obtaining complete and accurate documentation. It focuses on the specific workflows that the different documented structures require. The objectives of the archaeological survey were to document the buildings before restoration work and to give the 3D models to the project designers for the calibration of safety work. The case study is the castle of Larciano, which has undergone restoration and securing in recent years. More specifically, the works involved the castle walls and its fortified gates. Public institutions, architects, engineers, and archaeologists were involved in the project. The first phase of the restoration project, in 2019, focused on the three fortified gates to the castle. In 2020 the project moved to the eastern section of the walls, which was threatened by a real risk of collapse. On both occasions, archaeological surveys and analyses had to be matched with the need for restoration. During the

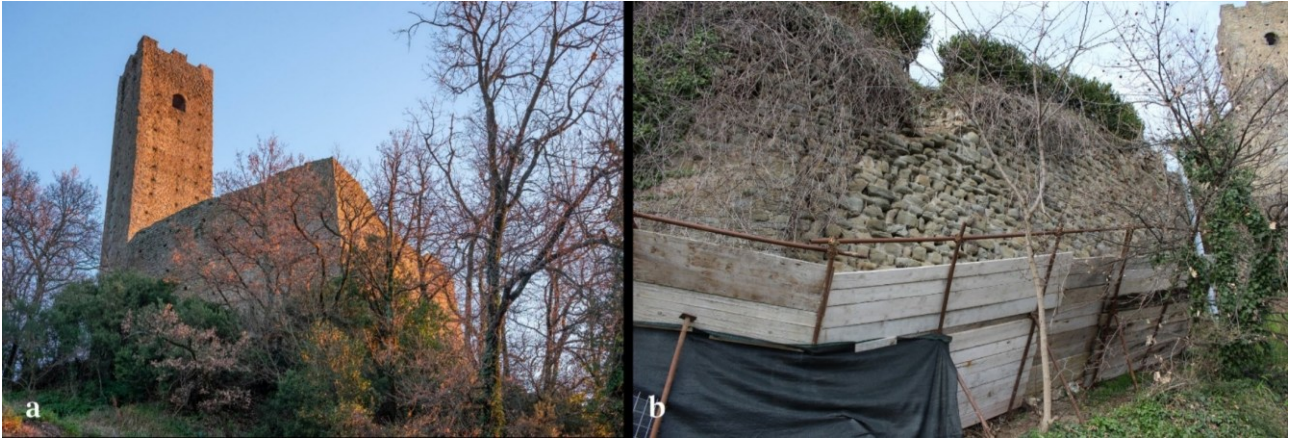
Fig. 1. The fortress of Larciano a), and part of the eastern wall before the restoration b). Vegetation, collapses, safety precautions and the steepness of the ground are visible (© Chiara Marcotulli).

The current feature of the castle still presents clearly readable traces of the fortification from the Guidi’s age and of the subsequent reorganization by the medieval Municipality of Pistoia (Figure 1). The trapezoidal fortress is located at the highest point in the northern part of the site and was restored in the 1970s. The walls, probably to be attributed to the reconstruction of the castle by the city of Pistoia in the 13th century, are preserved for one kilometre and along the route there are three gates,

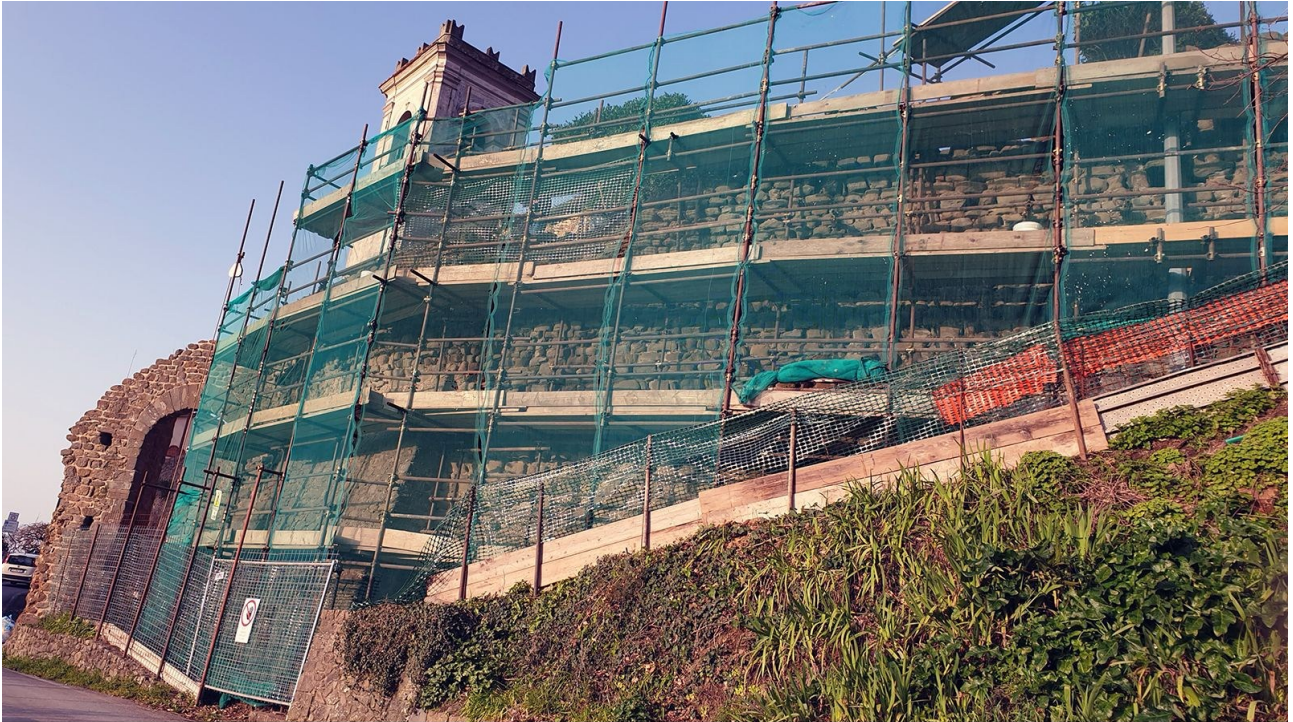
Fig. 2. The scaffolding of the wall: the floors made it hard to obtain vertical overlap and it forced to take very close images (© Chiara Marcotulli).

After cleaning the walls, it was still necessary to document the object in more detail, but the scaffolding represented a major obstacle for the photogrammetric survey: it was possible to shoot from no more than one metre away, on 7 different floors, with difficulty in overlapping the various floors due to the scaffolding planks (Figure 2). Obviously, the use of a drone was considered, but if before the removal of the vegetation it presented too high a risk of collision, after the cleaning of the wall and the erection of the scaffolding the situation was no more propitious: the safety of the scaffolding involved dense nets over the entire vertical surface. It was therefore not possible to shoot in front of the scaffolding with a drone.

Photos were taken from less than a metre away (the width of the scaffold planking), and each photo covered an area of a few square metres. The structure of the scaffolding (poles, planks, protective netting) made it impossible to have a wider view.
