Structured Light Scanning as a Monitoring Method to Investigate Dimensional Changes Due to Climatic Changes on Cultural Heritage

Kristina HOLL, Otto Friedrich University of Bamberg, Germany
Leander PALLAS, Otto Friedrich University of Bamberg, Germany
Paul BELLENDORF, Otto Friedrich University of Bamberg, Germany

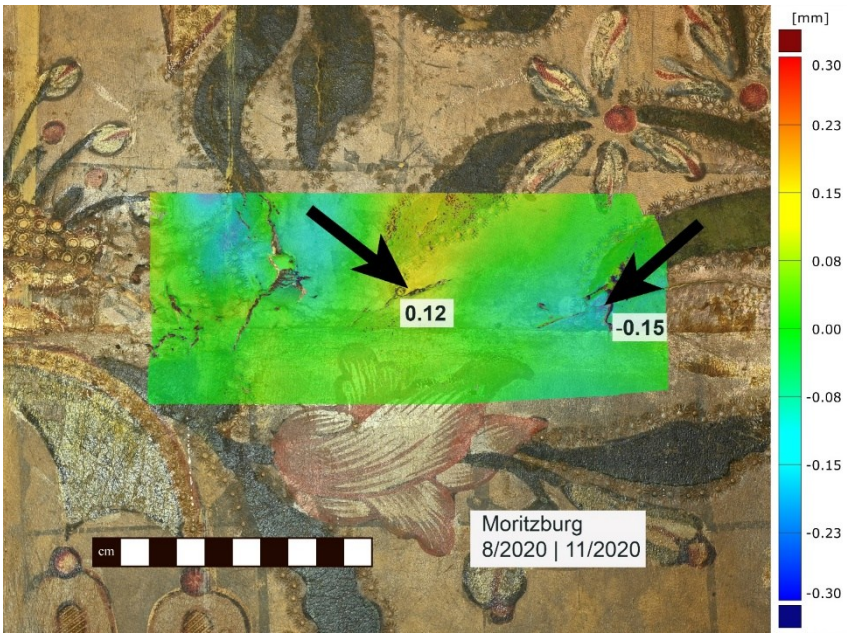
Fig. 6. 3D-Comparison from August and November 2020 laid on top of a coloured orthogonal photograph of the measured area. During the time the highest changes in relative humidity occurred. However, the reaction of the leather panel is low (± 0.15 mm) (© Leander Pallas/ Kristina Holl).

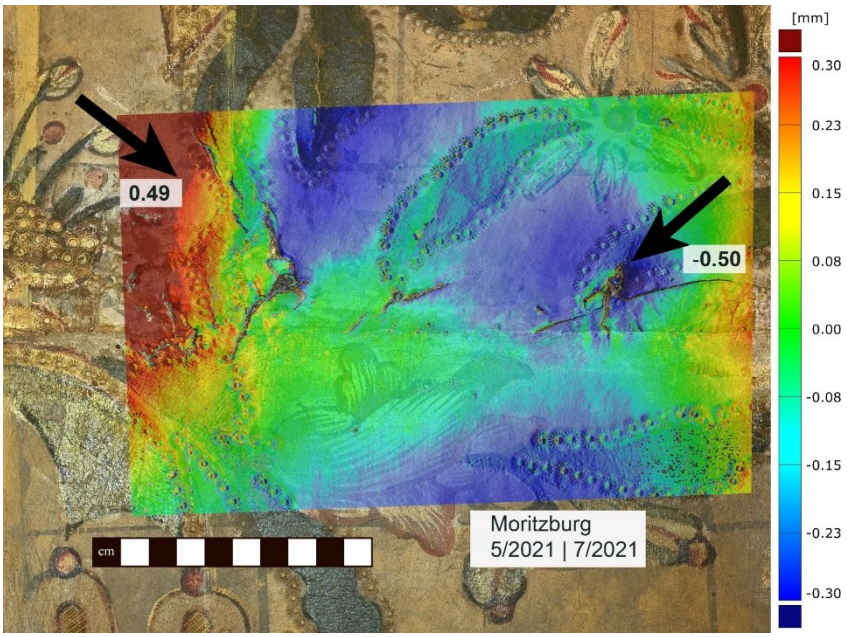
Fig 7. 3D-Comparison from May and July 2021 laid on top of a coloured orthogonal photograph. It shows the strongest movements of all measurement campaigns. A clear shift is visible within the leather panel, especially in already damaged surfaces (light blue to dark blue: movement to the back, light green to red: movement to the front). The measurements were executed with a 30 µm resolution. Here, a movement of about ± 0.5 mm is visible (© Leander Pallas/ Kristina Holl).

In conclusion, the examined panels show a clear mechanical response to short-term, monthly as well as seasonal changes in the environment. This was especially significant on the leather panels in Moritzburg castle, where changes of ± 0.5 mm were visible at a monthly period.

To prevent the historic furnishing in Moritzburg castle from future damage due to high temperatures and low relative humidity the improvement of the shading of the building is one opportunity. Another possibility is the use of intelligent automated ventilating systems. Here windows would open automatically, when the outside conditions are acceptable to keep the indoor climate stable and close when the conditions get inconvenient.
